NLTUA Operations Report – August 2023

FROM: Mark Huggard, Jacobs

DATE: September 14th, 2023

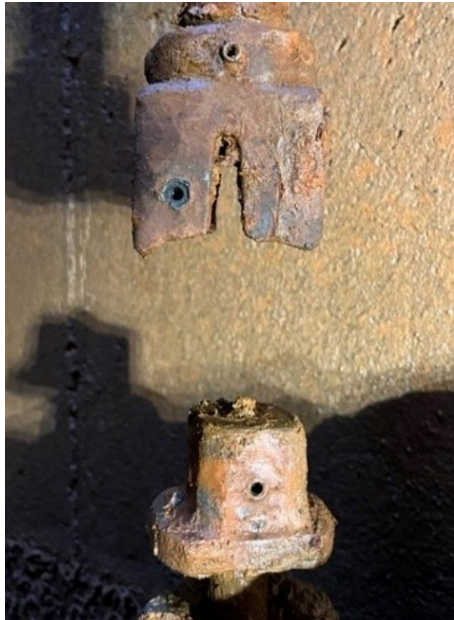
We replaced a faulty distribution valve pin for rapid infiltration bed #3a. Additionally, we took a proactive approach by replacing the valve pins in the adjacent valves for infiltration beds #3b and #3c. These pins are low-cost but necessitate a two-person confined space entry for replacement. This proactive replacement strategy helps save on future repair labor costs.

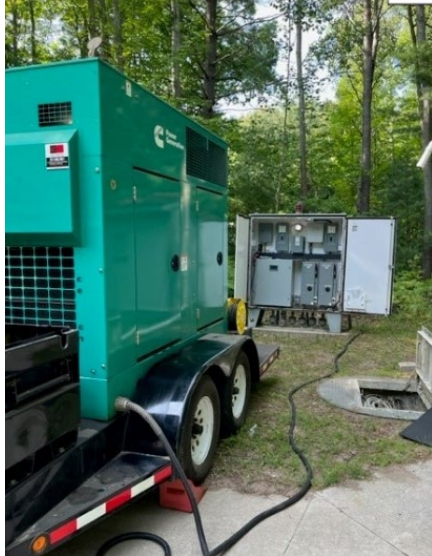
Northport Point Rd. Portable Generator Setup

On August 16th, we addressed another power outage at Northport point Rd lift station. The portable generator was staged until utility power supply was restored.

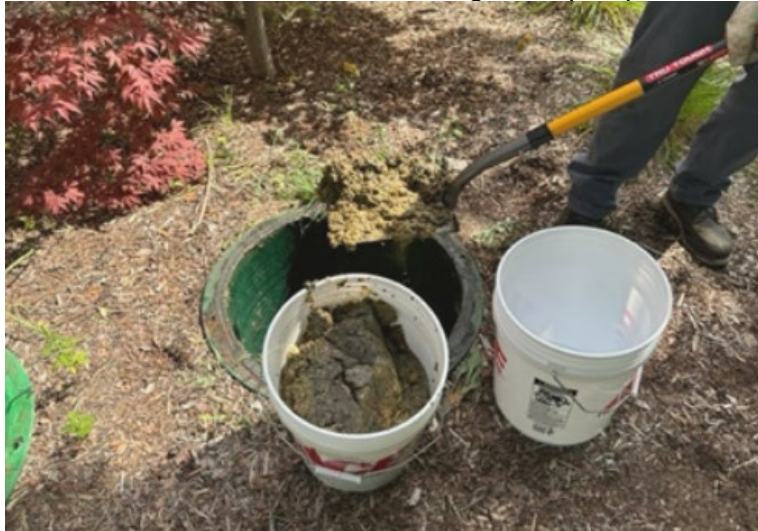
Grease removed from 110 Park St. grinder pump well
