NLTUA Operations Report – September 2023

FROM: Mark Huggard, Jacobs

DATE: October 18th, 2023

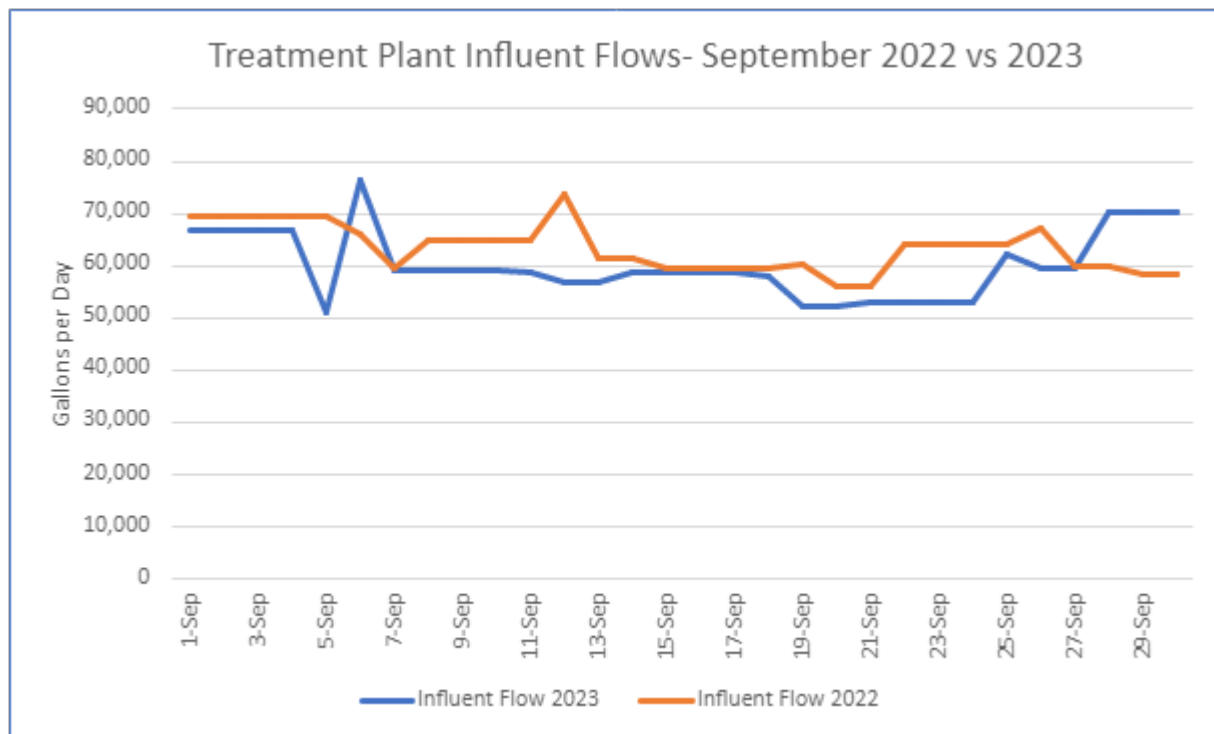
The above graph compares the plant influent flows of last year to that of 2023.

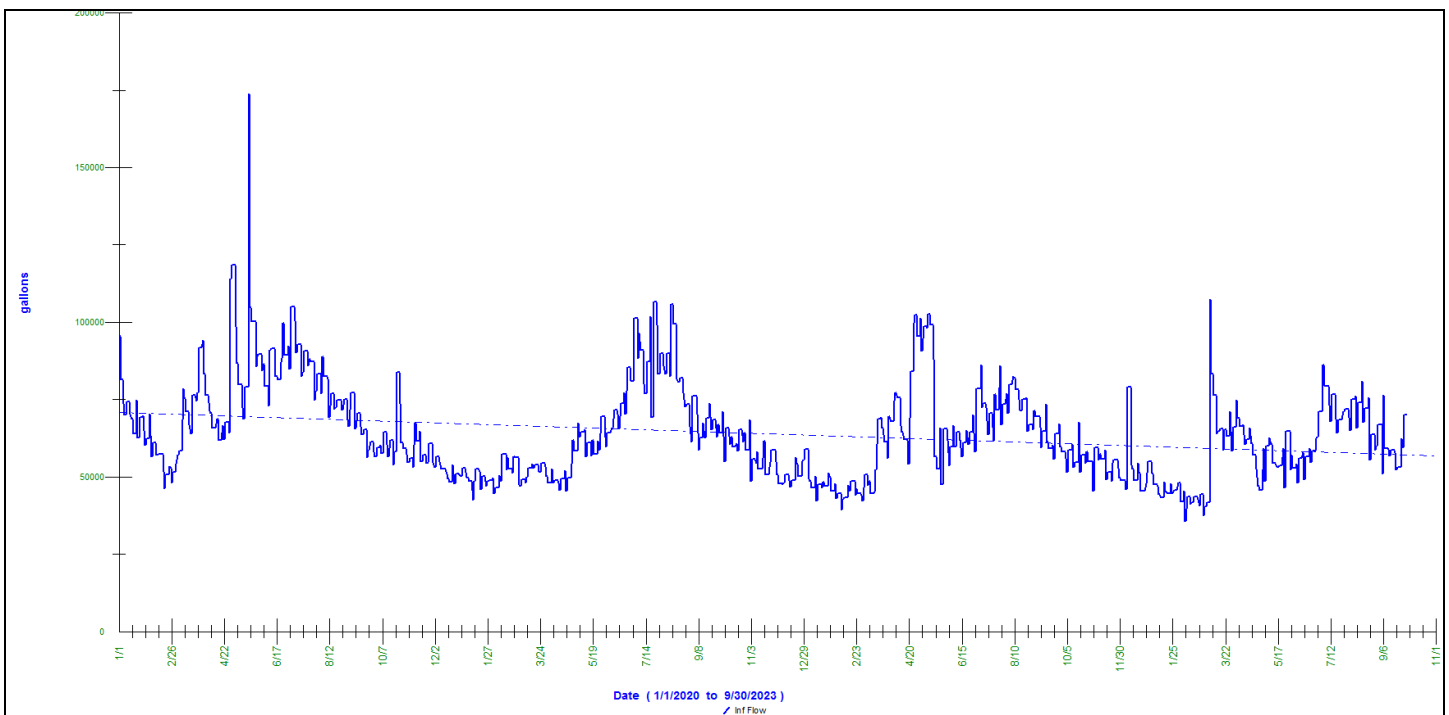
The reason behind this change is likely linked to the decrease in flow rates over the past few years, as shown in the accompanying graph. This reduction in flow rates results in less run time on the fine screen therefore extending the longevity of the brushes.

- We completed the replacement of the influent vertical fine screen brushes, which has been the need on an annual basis, for some time. However, during this latest replacement, we found that the brushes had not worn out as quickly as expected, indicating that they didn't need replacement after just one year going forward. As a result, we replaced the brushes and have made a change to our preventive maintenance schedule, extending it to every two years.
