# Technical Memorandum

**To:** Jered Ottenwess, Village of Northport  
**From:** Jenny Pitcher, P.E.  
**Date:** July 21, 2026  
**Re:** Post Storm Event Northport Dam Assessment  
Northport, MI  
**Project No.** 2503882

# Northport Post Storm Dam Assessment

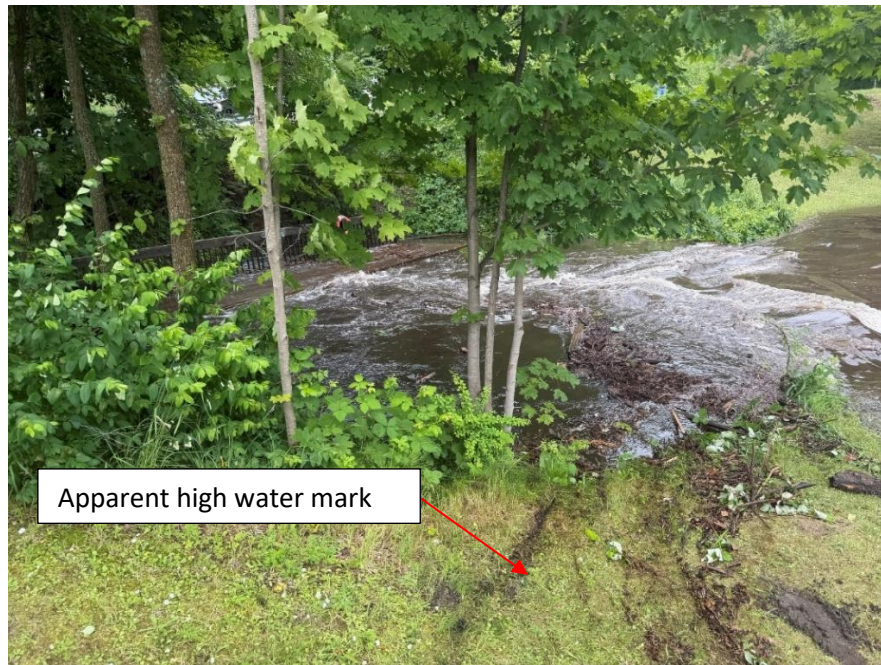
The downstream roadway culvert reached capacity during the storm, causing water levels upstream of 3rd Street and downstream of the dam to rise well above the top of the culvert and to within approximately five feet of the road low point (see photos 1 and 2). This backwater condition temporarily impounded water upstream of the roadway culvert, submerged the dam, and eliminated freeboard at the spillway. At that point, flow over the dam was no longer controlled by the stoplogs. Village DPW reported that the water level reached approximately two to three feet above the spillway crest.

Photo 1. – Photo taken from left downstream embankment looking west. Flood is on trailing limb of hydrograph as can be seen by the flotsam. Note backwater caused by hydraulic limiting of road culvert and displaced fishing pier. (6/29/2026 @ 2:01 PM– Provided by the Village)

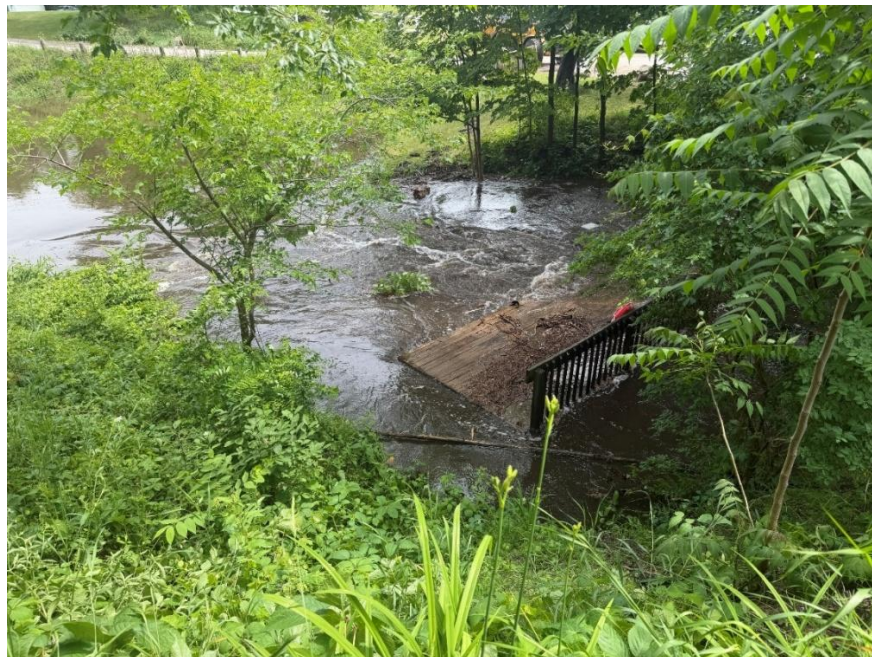
Photo 2 – Similar photo showing conditons as viewed from the right downstream high ground. (6/29/2026 @ 2:01 PM – Provided by the Village)

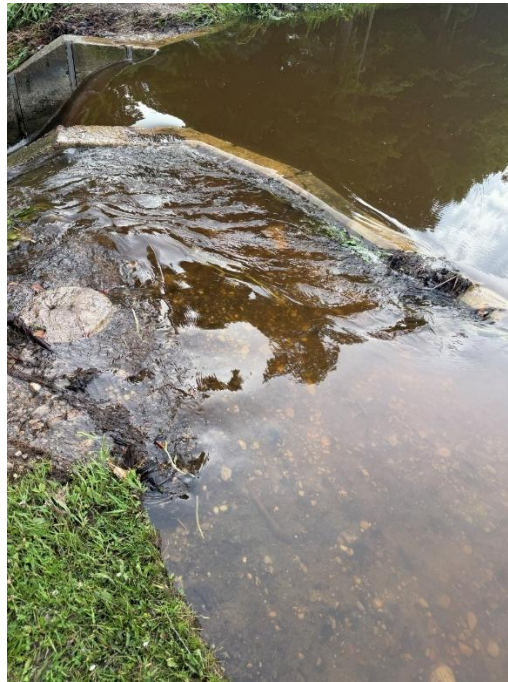
Beginning June 30<sup>th</sup>, Village DPW removed stoplogs to manage flow and drew down the impoundment for dam inspection, potential repairs, and dam safety considerations (see photos 3 -7). After the drawdown, Village DPW observed displaced riprap at the dam and noted that most of the cobble-sized rock had washed downstream. Village DPW did not observe apparent changes in the concrete spillway structure.

Photo 3 – Left embankment looking from the right embankment during flood as the water recedes.  
(6/30/2026– Provided by the Village)

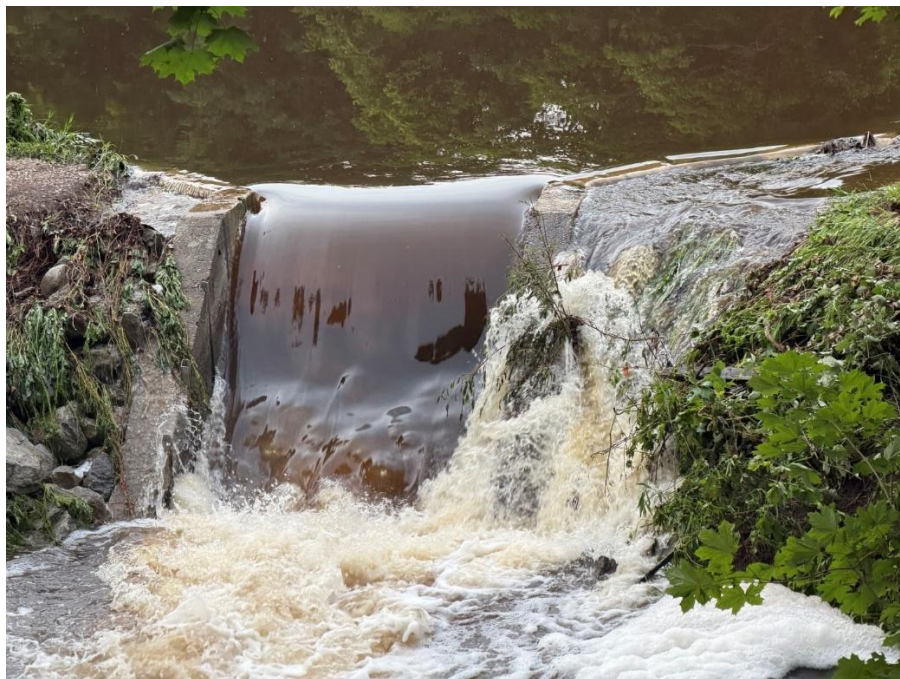
Photo 4 – Looking upstream towards the concrete structure before the stop logs were pulled.  
(6/30/2026 – Provided by the Village)

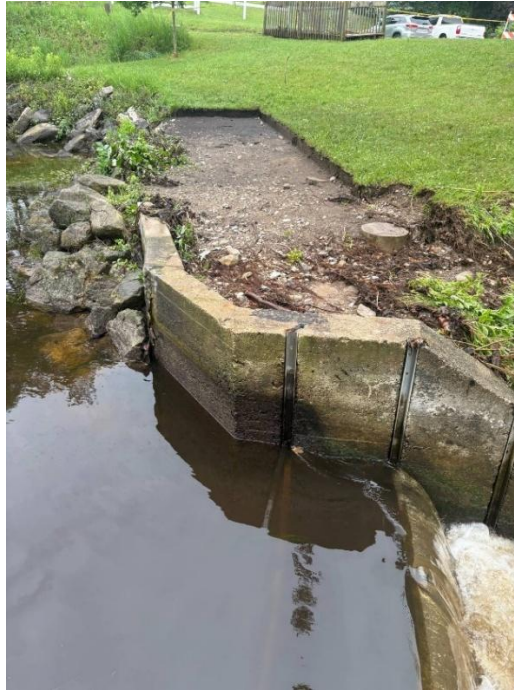
The downstream embankment appears to have experienced erosion and movement of material, most notably along the upper portions of the left and right downstream embankments (see photo 8 and photos 13-18). The areas of material loss are generally consistent with photographs provided by the Village (see photos 5-7), which show conditions as floodwaters receded and downstream water levels dropped below the embankment crest while overtopping continued above the spillway. The temporary backwater condition at the downstream culvert which submerged the dam during the flood event likely reduced erosive forces on the embankment and structure. This may have limited additional erosion along the downstream embankments.

Photo 5 – Left embankment looking from the right embankment during dewatering of impoundment.  
(7/1/2026– Provided by the Village)

- Complete maintenance along the left and right downstream embankments to restore the crest and stabilize the slopes along the training wall to the original grades.
- Complete the previously proposed and permitted concrete repairs.

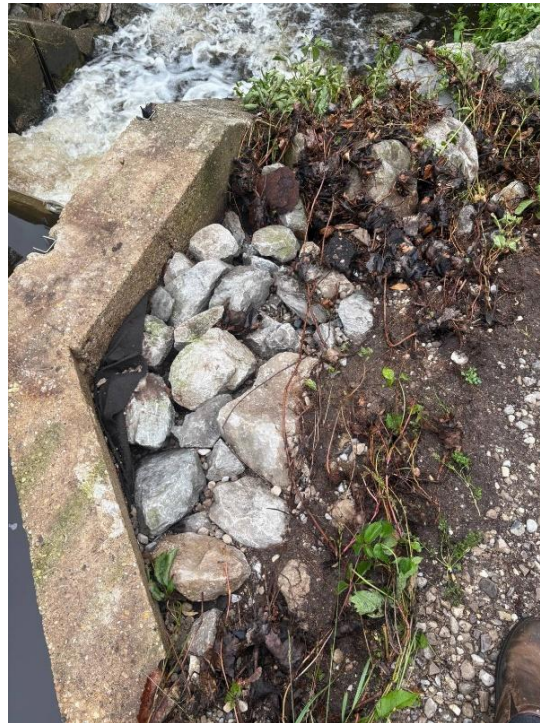
Photo 6 – Right downstream embankment along the right downstream training wall. (7/1/2026–  
Provided by the Village)

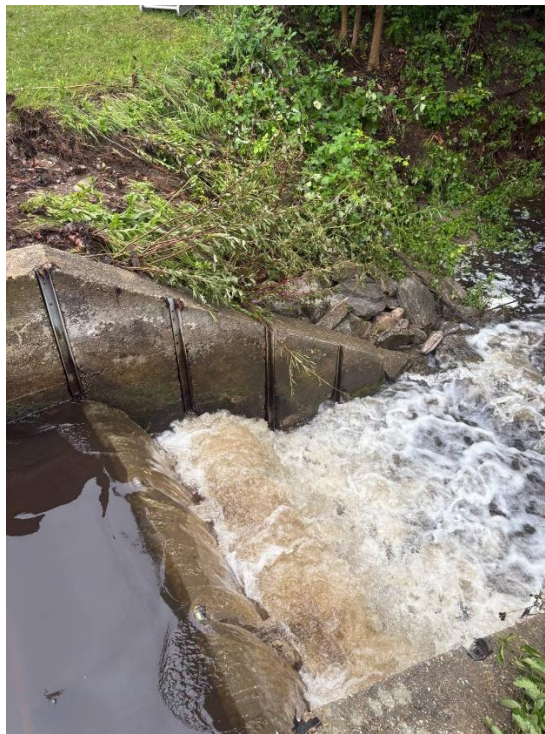
Photo 7 – Left downstream embankment during drawdown. (7/1/2026– Provided by the Village)

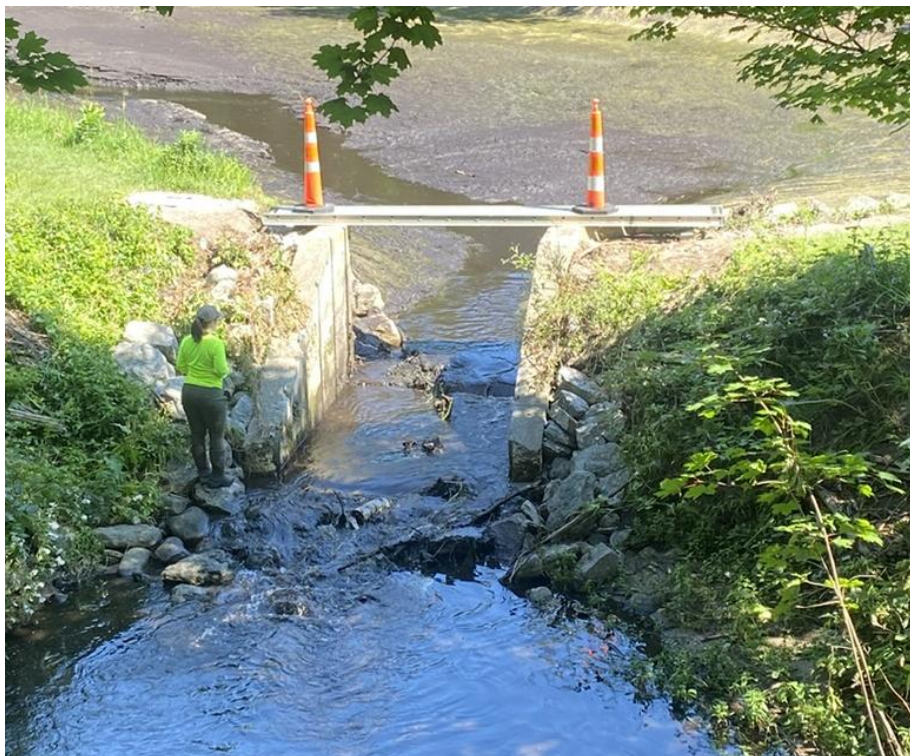
Photo 8 – Looking upstream at the concrete spillway after the stop logs were pulled. (7/7/2026)

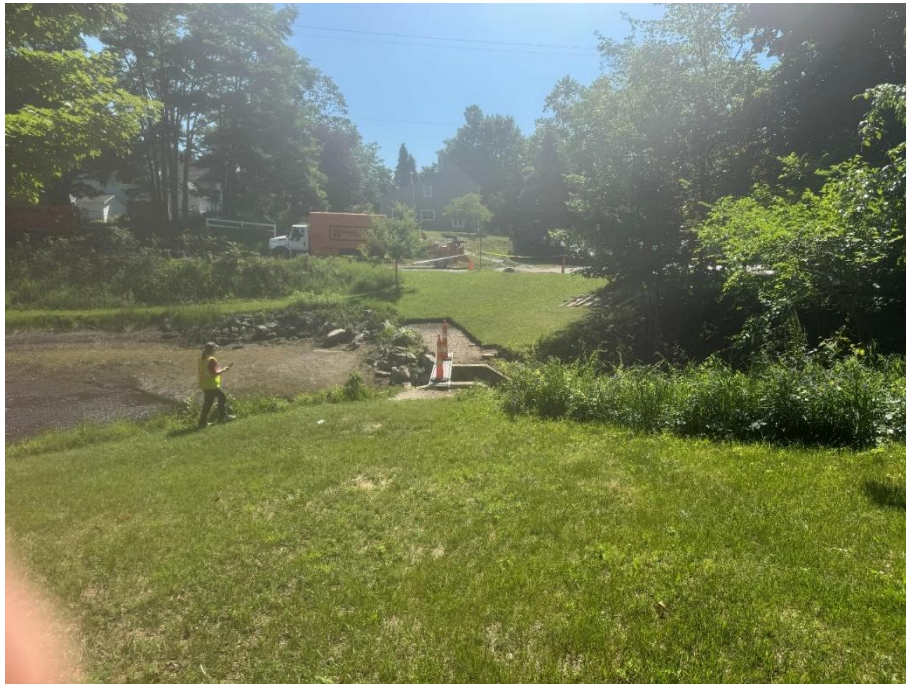
Existing deficiencies such as dense and woody vegetation along the downstream embankment remain (see photo 9). GEI did not observe evidence of internal material movement or embankment instability; however, dense vegetation and remaining riprap limited the visual assessment. Undercutting was noted on the right downstream bank near the widest part of the plunge pool.

Photo 9 – Right embankment looking eastward from the right abutment. (7/7/2026)

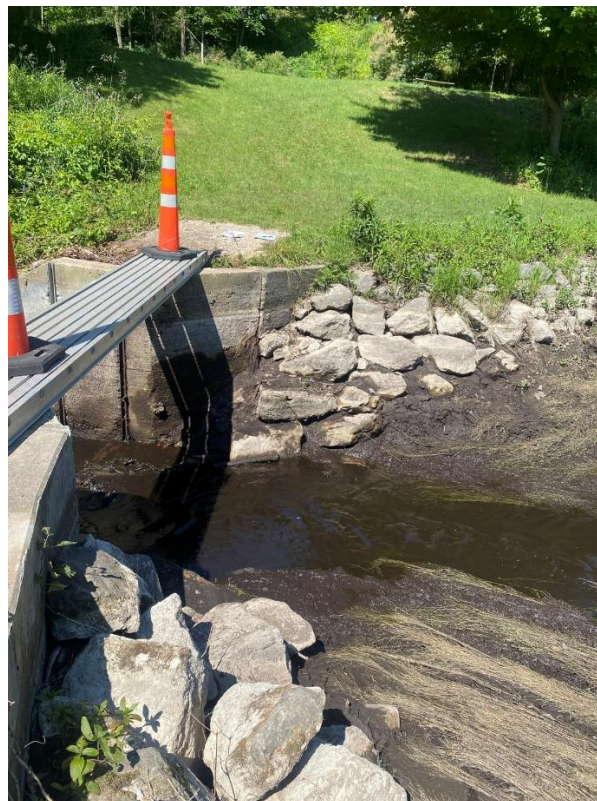
On the upstream side, some riprap appeared to be missing from the toe of the right upstream embankment (see photo 10). The remaining riprap on the left and right embankments were generally twelve inches in diameter or larger (see photo 11 and 12). Based on previous inspection photographs from 2023 (see photo 19), the spillway condition appeared unchanged, with no visible increase in concrete spalling, cracking, or deterioration. GEI probed the apron with a measuring rod, and the apron and corners appeared intact.

Photo 10 – Right upstream embankment looking from the left embankment. (7/7/2026)

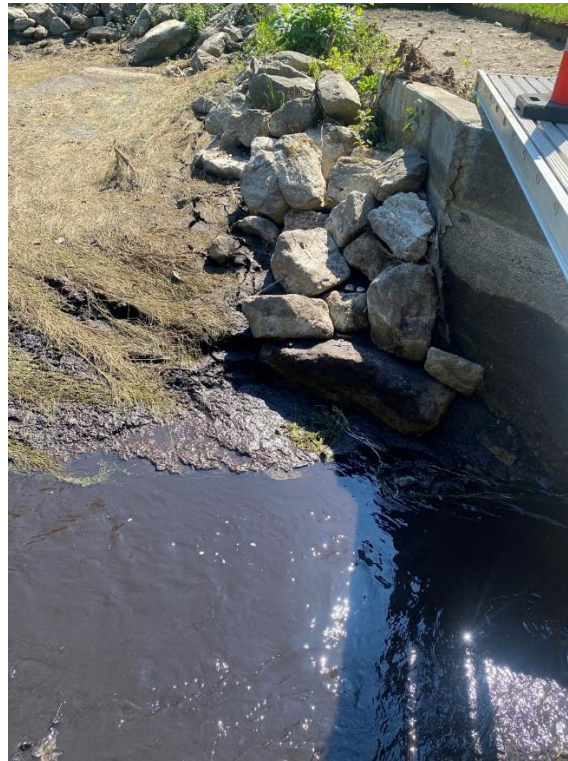
Photo 11 – Left upstream embankment looking eastward after dewatering. (7/7/2026)

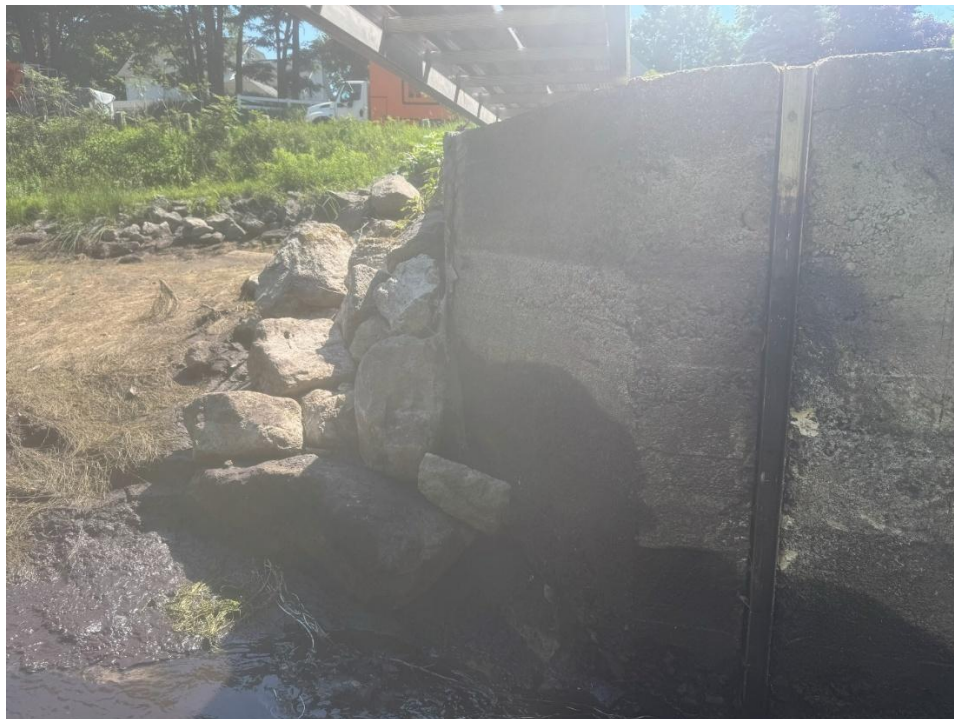
Photo 12 – Left upstream embankment after dewatering looking eastward. (7/7/2026)

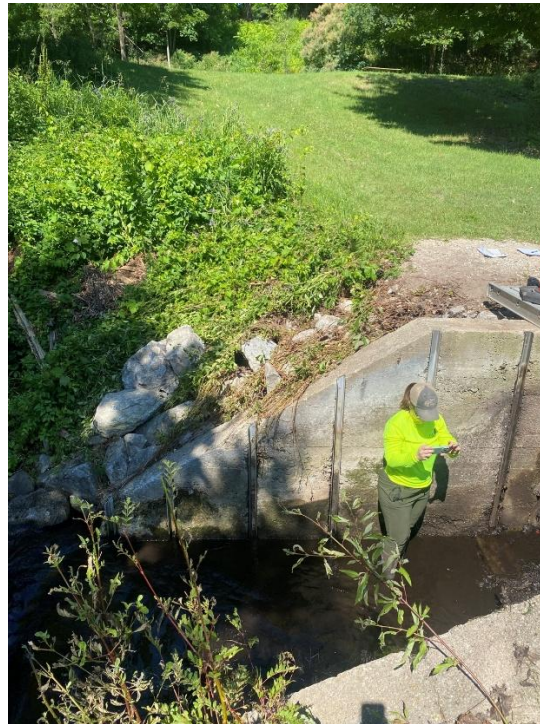
Photo 13 – Right downstream embankment looking towards the right abutment. (7/7/2026)

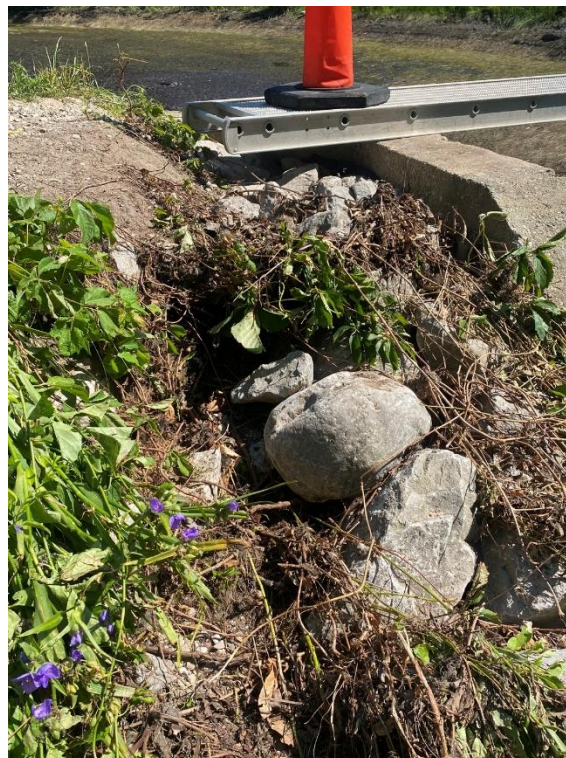
Photo 14 – Right downstream embankment looking towards the reservoir. (7/7/2026)

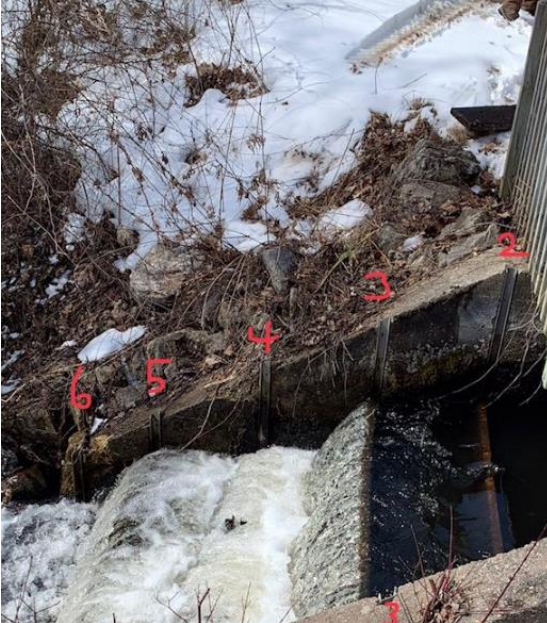
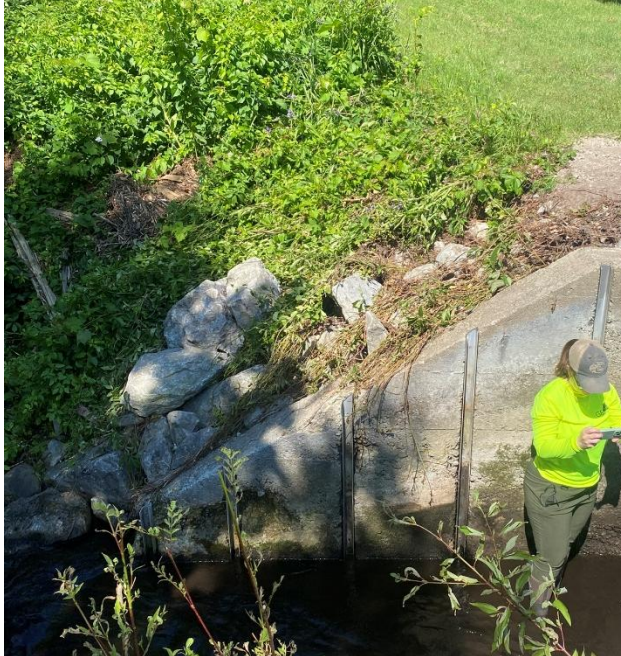
On July 7<sup>th</sup>, GEI dam safety engineers visited the site to complete a post-storm dam assessment. The team observed matted vegetation and vegetation debris (flotsam) that generally matched the water surface elevation described by Village DPW staff. Matted vegetation from overtopping extended approximately thirteen feet onto the right side of the dam (see photo 15) and approximately eight feet onto the left side of the dam (see photo 16).

Photo 15 – Right downstream embankment and training wall comparison. (7/6/2026)

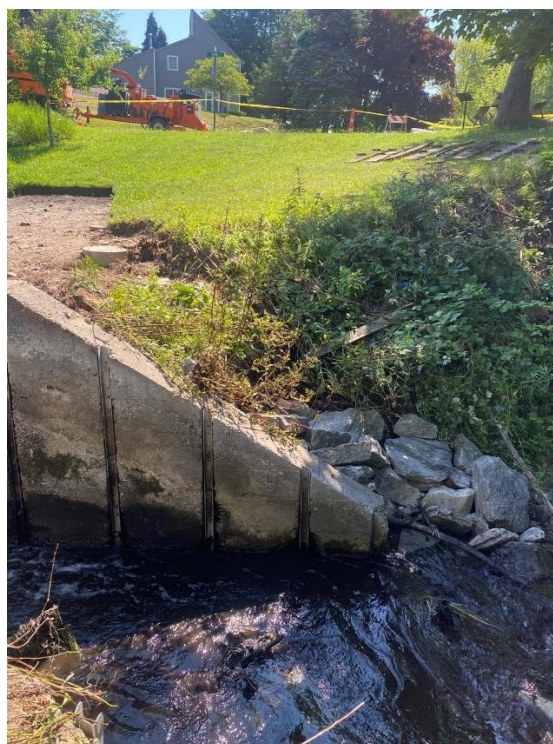
Photo 16 – Left downstream embankment and left training wall. (7/7/2026)

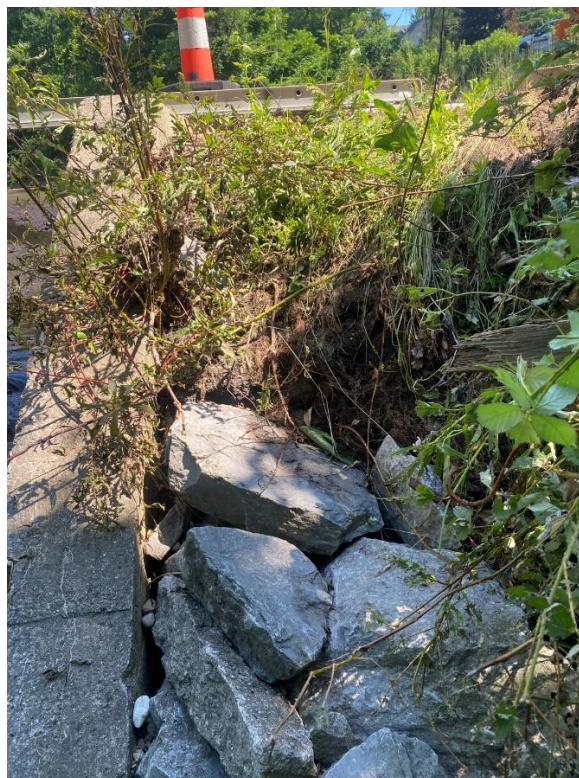
Photo 17 – Left downstream embankment looking toward the reservoir. (7/7/2026)

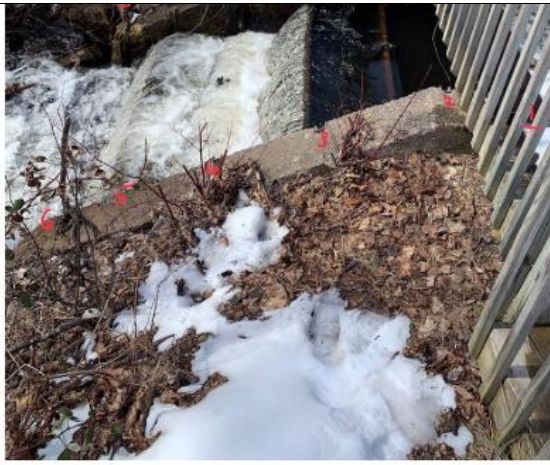
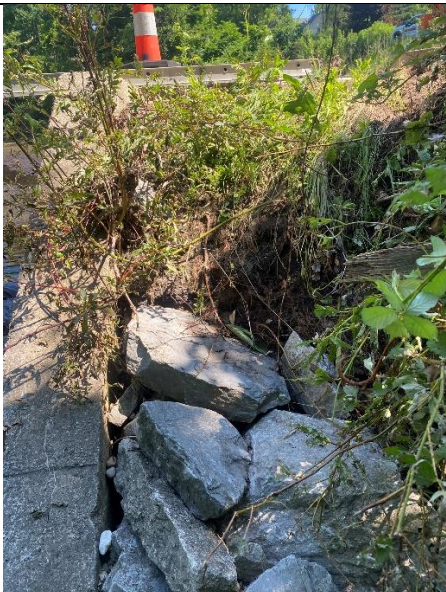
Photo 18 – Left downstream embankment and left training wall comparison. (7/7/2026)

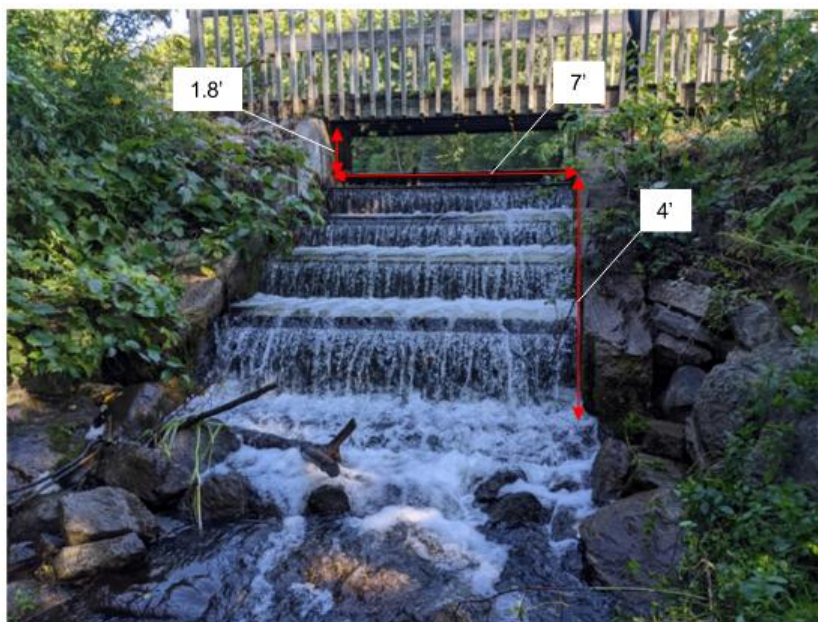
Photo 19 – Looking upstream toward the concrete spillway in 2023. (2023 Dam Inspection Report-GEI )

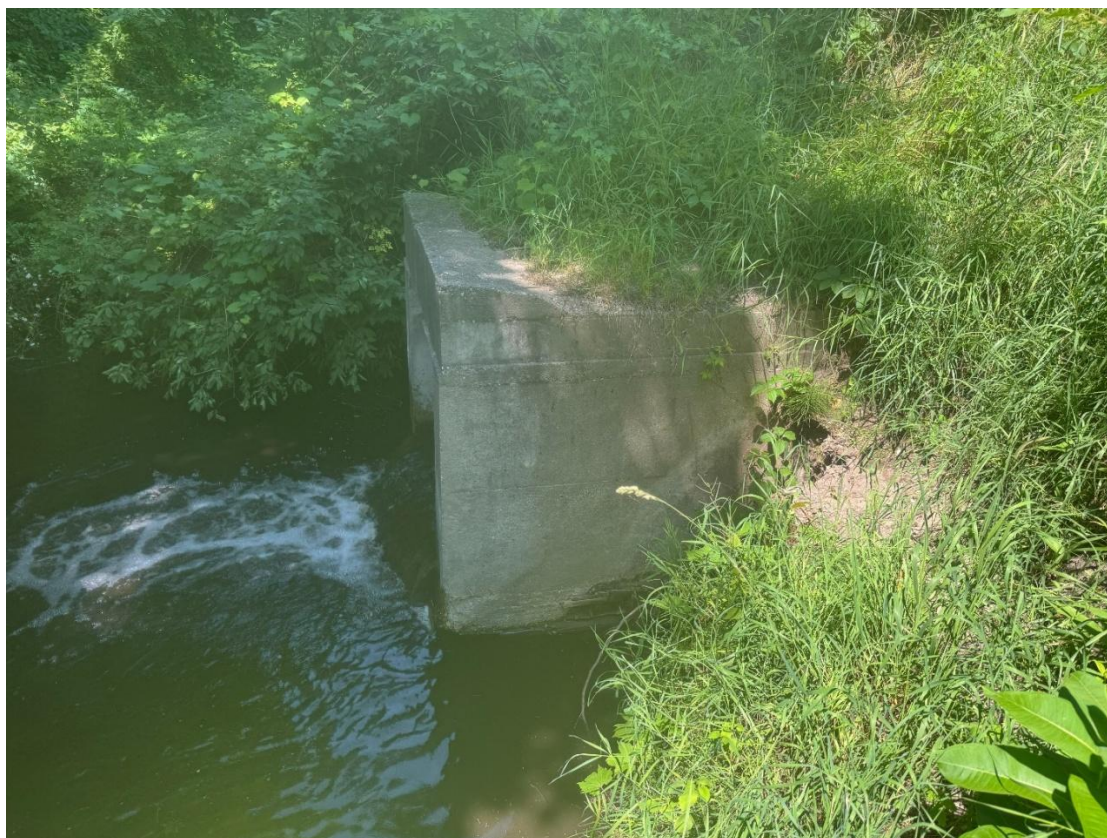
GEI also observed the downstream roadway culvert during the field assessment. At the culvert's outlet, water levels remained high, and the culvert was perched above the tailwater at the time of the observation (see photo 20). Slope deterioration was observed along the slope on the left downstream side of the culvert. GEI did not access the area more closely because of safety concerns (dense vegetation, high velocity flows, and limited visibility). GEI recommends that the Village coordinate with their Engineer to evaluate the affected slope and culvert and identify appropriate repairs.

Photo 20 – Downstream end of 3<sup>rd</sup> Street culvert looking from the left. (7/7/2026)
